V. Y. Ng, et al. [2011] Med. Hypotheses Res. 7: 39–42.

Prophylactic Fixation of the Femoral Neck after Hip Resurfacing Arthroplasty

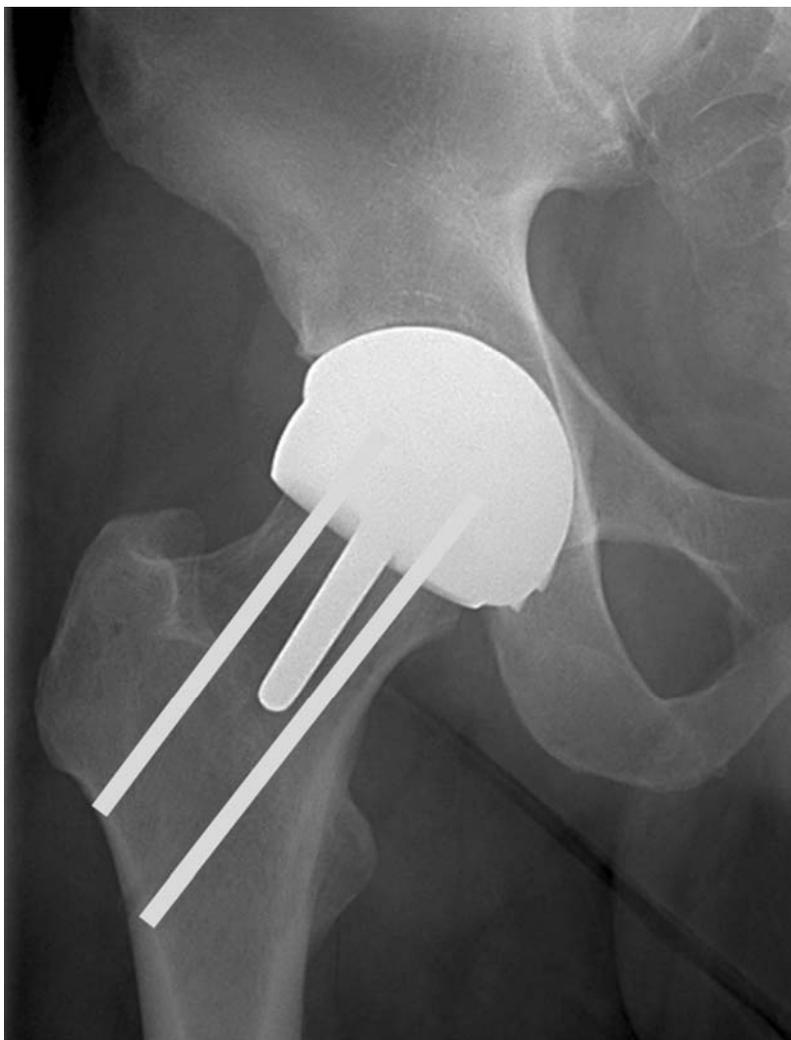
Figure 1. Anteroposterior radiograph of a hip resurfacing implant with proposed prophylactic pins across the femoral neck.

We hypothesize that prophylactic fixation of the femoral neck can reduce the risk of fracture after hip resurfacing arthroplasty and treatment of FAI (FIG 1). While we do not advocate applying this strategy to all patients, those with an increased risk of fracture secondary to surgeon technical error during the primary procedure may benefit from this preventive measure.

We propose that prophylactic internal fixation of the femoral neck can reduce the risk of fracture in cases which the surgeon intraoperatively recognizes a technical error. Parallel pins are routinely used during treatment of non-displaced femoral neck fractures and tension-side stress fractures. It is a relatively easy technique and can bail out inexperienced surgeons during hip resurfacing arthroplasty. Exposure of the femoral head during machining of the proximal femur allows for retrograde placement of the parallel pins. Functioning similar to a reinforcing bar (“rebar”), the pins would increase the load to failure of the

proximal femur. Similar to industrial construction, concrete and bone are both very strong in compression, but would benefit from metal rebar to resist tension. To the knowledge of these authors, this technical concept has not previously been reported.
